# Manhole Inspection Summary

Manhole # S33GG\_032MH

**Location** Address: **MARYLAND AVE**

Cross Street: **OLIVER ST**

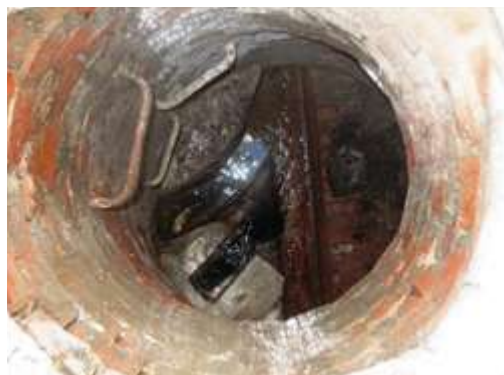
Top View

Corroded steps. Evidence of surcharge - Bench debris.

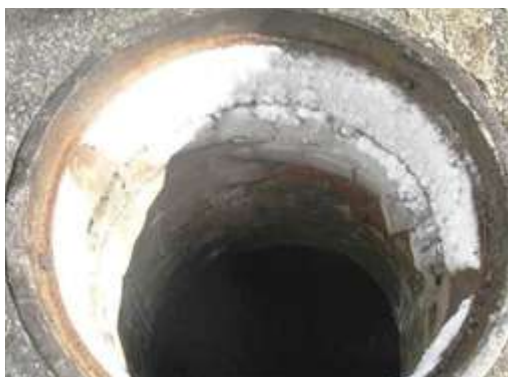
Defect

Adjustment deterioration, loose brick, and infiltration. Corbel and Barrel infiltration.

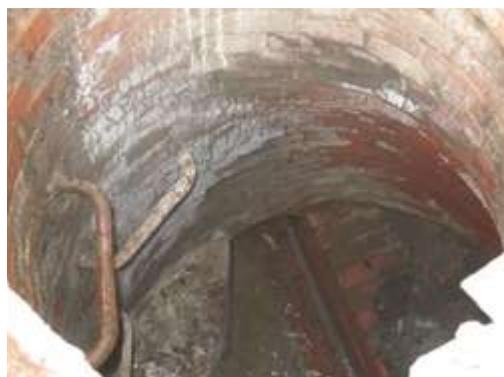
Defect

Corbel and Barrel infiltration.

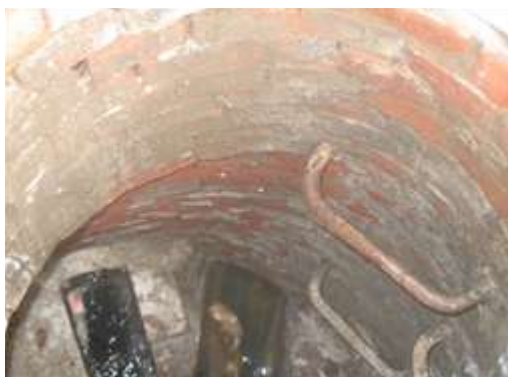
Defect

Adjustment deterioration and infiltration. Corbel and Barrel infiltration.

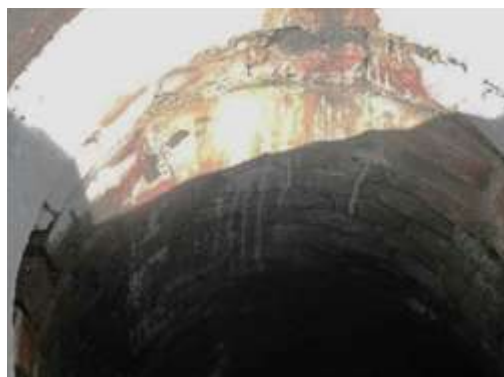
Defect

Adjustment deterioration and infiltration. Corbel and Barrel infiltration.

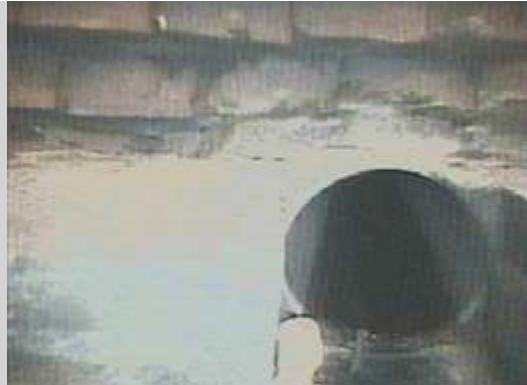
### 8 in. Circular Gravity Sewer Pipe Out @ 12 O'Clock

Barrel deterioration and infiltration. Channel deterioration.

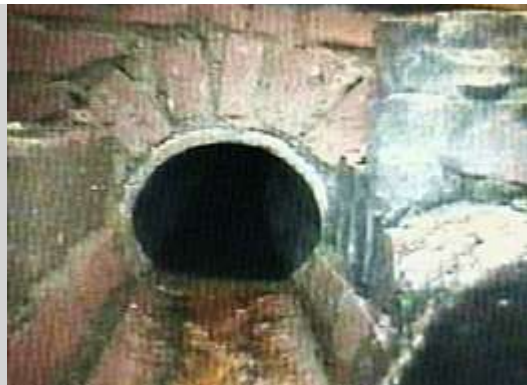
### 8 in. Circular Gravity Sewer Pipe In @ 6 O'Clock

Infiltration: **Evidence** Pipe Seal Cond: **Unknown**

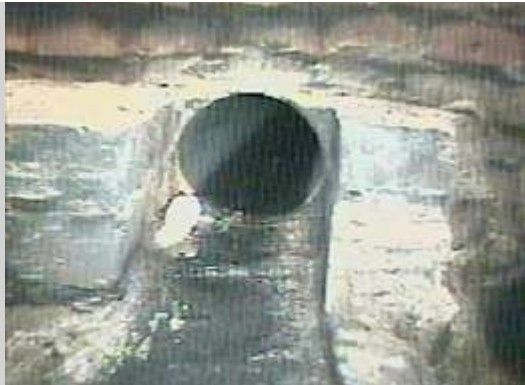
Pipe In @ 7 O'Clock

Deposits: ☐ None ☒ **Mud** ☐ Sludge ☒ **Debris** ☐ Grease

Silt Depth: **0.5** (in.) Deposits Extent: **Light**

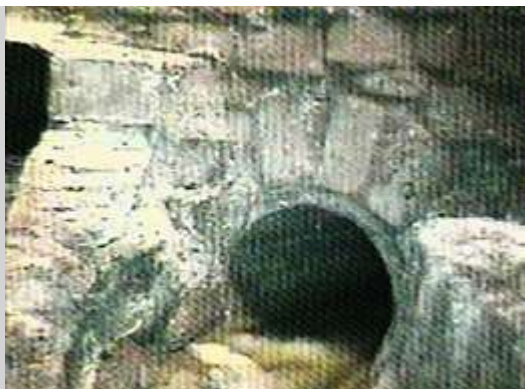
Pipe In @ 8 O'Clock

Barrel deterioration and infiltration. Channel deterioration.

Deposits: ☐ None ☒ **Mud** ☐ Sludge ☒ **Debris** ☒ **Grease**

Infiltration: **Evidence**
